CALIBRE

Home Inspections

INSPECTION CONDITIONS & NOTES

Address
Grayson, GA 30017.

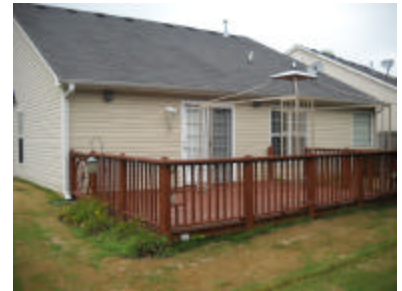
The back slope of the soil is not pitched away from the foundation properly. Slope should fall away from the foundation at a minimum of 1/2 inch per foot and extend at least 10 feet away from the foundation. IRC 2006; R401.3. The condition of the grounds at this point is marginal and should be monitored over time.

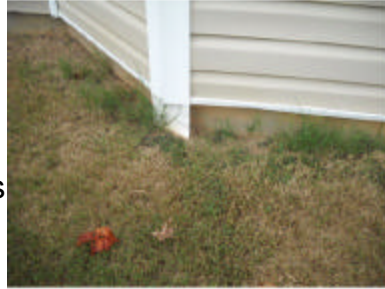
Siding is touching/(close to) ground/concrete . This promotes water and termite damage. Only brick siding is allowed to touch the ground as long as the level of the dirt touching the brick is lower than the interior wood building materials by four inches. Termite clearance letters for sale of the property might be hindered. Please check with the present exterminator company. Noted around the bay window. Vision blocked at the back deck area.

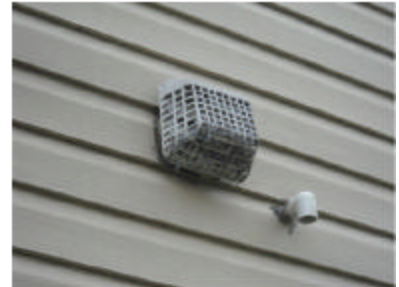
Vent cover(s)/screen(s) missing or not venting properly.

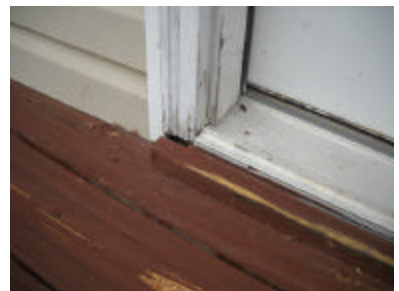
Back door trim has some dry rot noted at the bottom molding.

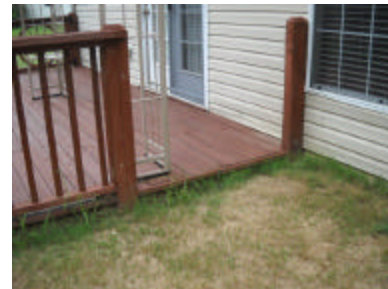
Access to deck underside is blocked. Restricted viewing is noted. Low elevation of deck prevents any viewing under the deck structure.

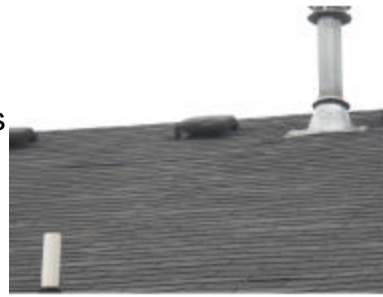
"Nail pops" are noted at roof shingles. This could be evidence of poor ventilation in the attic. When a roof heats excessively it expands and contracts and pushes roofing nails out of the sheathing. Noted at the back of the house.

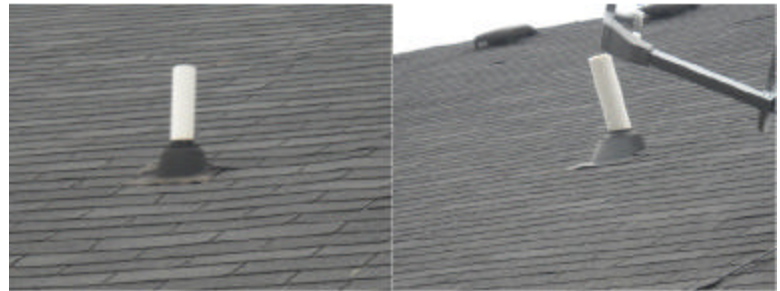
Poor vent boot condition exists. The vent boot is aging or is damaged from falling debris. Most vent boots require replacement after 6 to 12 years.

Plumbing vent is not vertical. Likely damage at the inside attic area.

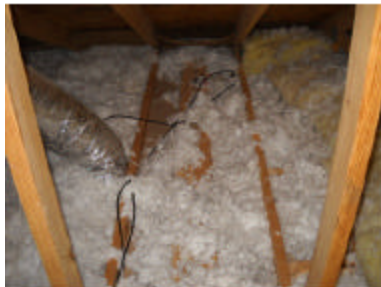
The insulation is somewhat compacted and the true R-Value at this point may be less than that was originally installed. Adding more insulation will raise the R-Value.

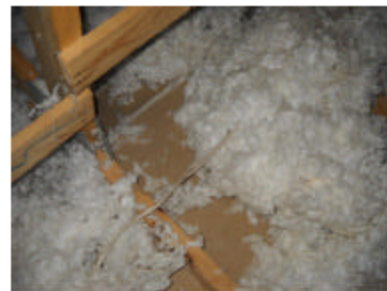
The insulation has been disturbed and good coverage is no longer present. The general volume of the insulation appears too low to adjust and create good coverage.

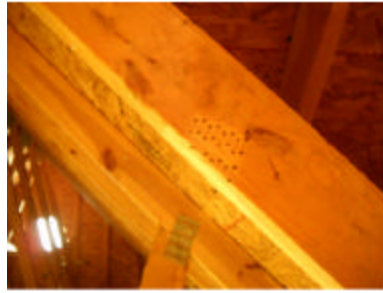
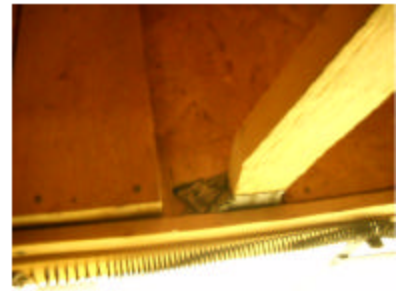
Cut, split, missing or damage truss noted at the step entry way.

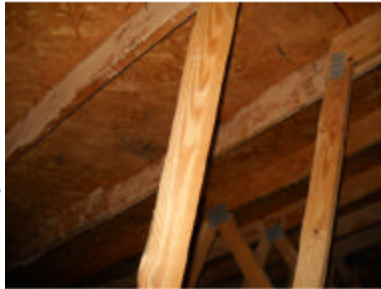
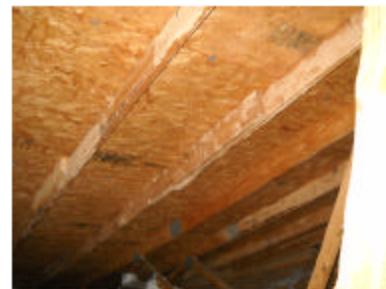
Previous damage was repaired, at rafters at the right side of the front middle. The repair appears sufficient though not professionally completed. No other damage or present leaking is visible. Any damage on truss systems could be significant. Assuring the damage is fixed satisfactorily would require an evaluation by the engineering department of a truss manufacturer (the original manufacturer is not necessary). Some fixes may be as simple as sistering (scabbing) the damaged member; others may require replacement of the entire truss. We routinely suggest obtaining a letter from a truss company assuring a proper fix

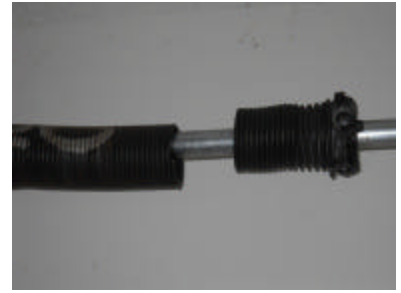
Major damage is noted. Broken spring is visible; the door was not tested.

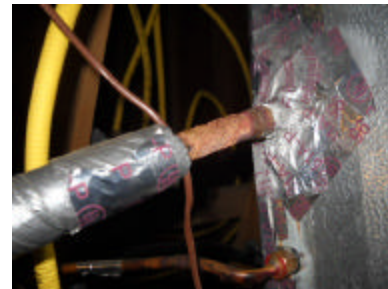
The insulation on the coolant line is loose/off/ineffective at the attic coil unit.

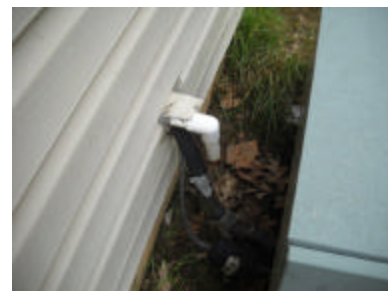
The condensation drain line discharges in the back of the compressor pad; the volume of water discharged from the condensation drain line could wash away a lot of dirt over time and cause numerous problems. We often recommend extending the drain line discharge to the other side of the compressor unit. This will help avoid future damage from erosion. An inexpensive easy solution could be extending the drain line with a typical sump pump drain line.

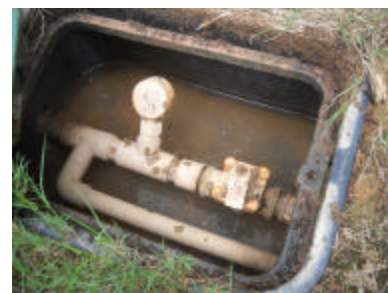
Water main exterior cut-off is flooded with water.

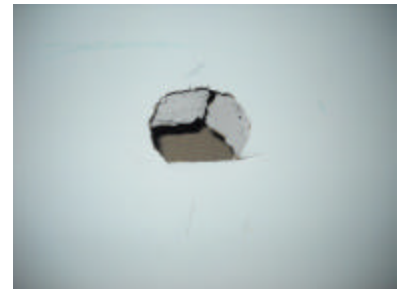
Damage at the left front bedroom.
